The Design, Construction and Test
of a Direct Reading Engine Indicator

THE DESIGN
CONSTRUCTION AND TEST
OF A DIRECT READING
ENGINE INDICATOR

THESIS

ELECTRICAL ENGINEERING

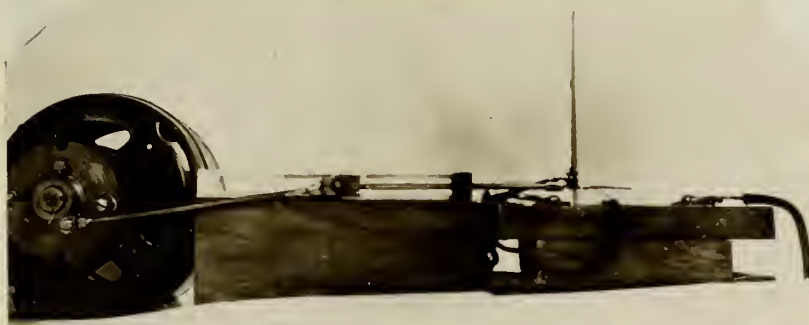
Fig. 3. Machine for Testing Sliding Contacts.

For the purpose of developing a slider a machine was constructed shown in Figure 3 that would give the motion of an indicator piston. A one-fourth horse-power direct current shunt motor was used, with resistance in both armature and field circuits for speed control and speeds from zero to 4500 revolutions per minute were available. By means of a crank-pin on the shaft and a rod connecting the pin to a cross-head, the rotation of the armature was changed to the

reciprocating motion of the indicator. Fastened to the cross-head was another rod the ends of which extended over the bridge supports and carried the slider to be tested.

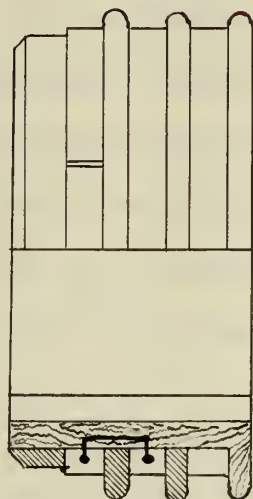
Fig. 30. Details of Commutator.

A metal sleeve was used as the base upon which to build the rest of the commutator since that would be easier to fasten to any shaft it would be put on, and furnished a substantial support for the insulating materials and rings put outside of it. A wooden sleeve with a collar at one end was turned so that it fit snugly around the brass sleeve and extended a little over each end so that the brass could not come in contact with any near-by metal parts of the engine. Two brass rings were then cut from a piece of two-inch

to the brass lining and a set-screw put through it. It was tested for shorts and grounds at all stages of construction. The completed commutator is shown in Figure 30.

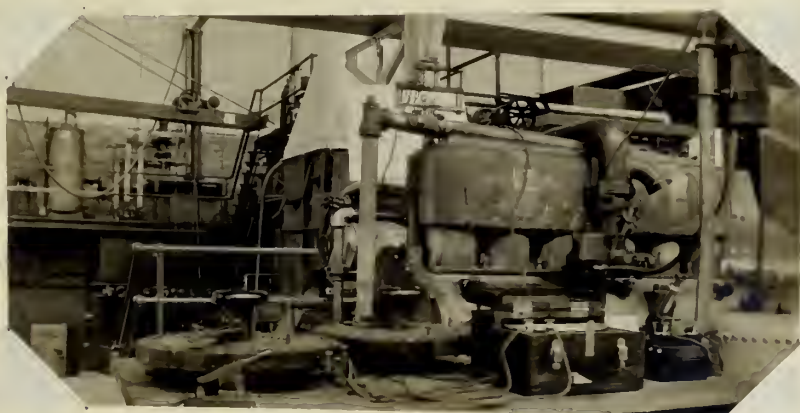
Fig. 37. Indicator and Apparatus on Peerless Engine.

When the galvanometer was at zero and the bridge wire current was fixed at one ampere, the engine was started. The galvanometer did not give much of a reading when the engine was running light,

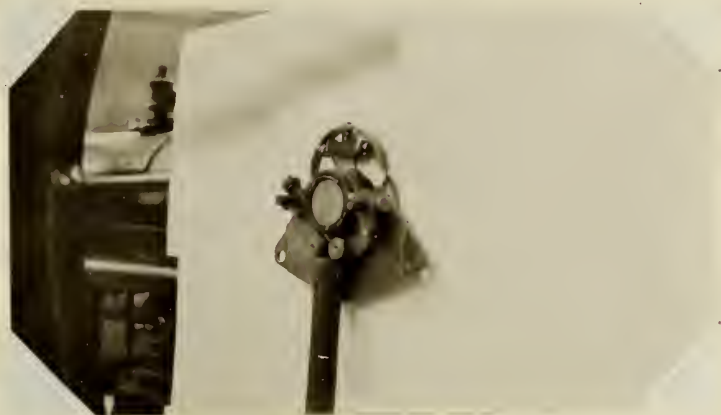
Fig. 38. Commutator and Brush Holder on Otto Engine.

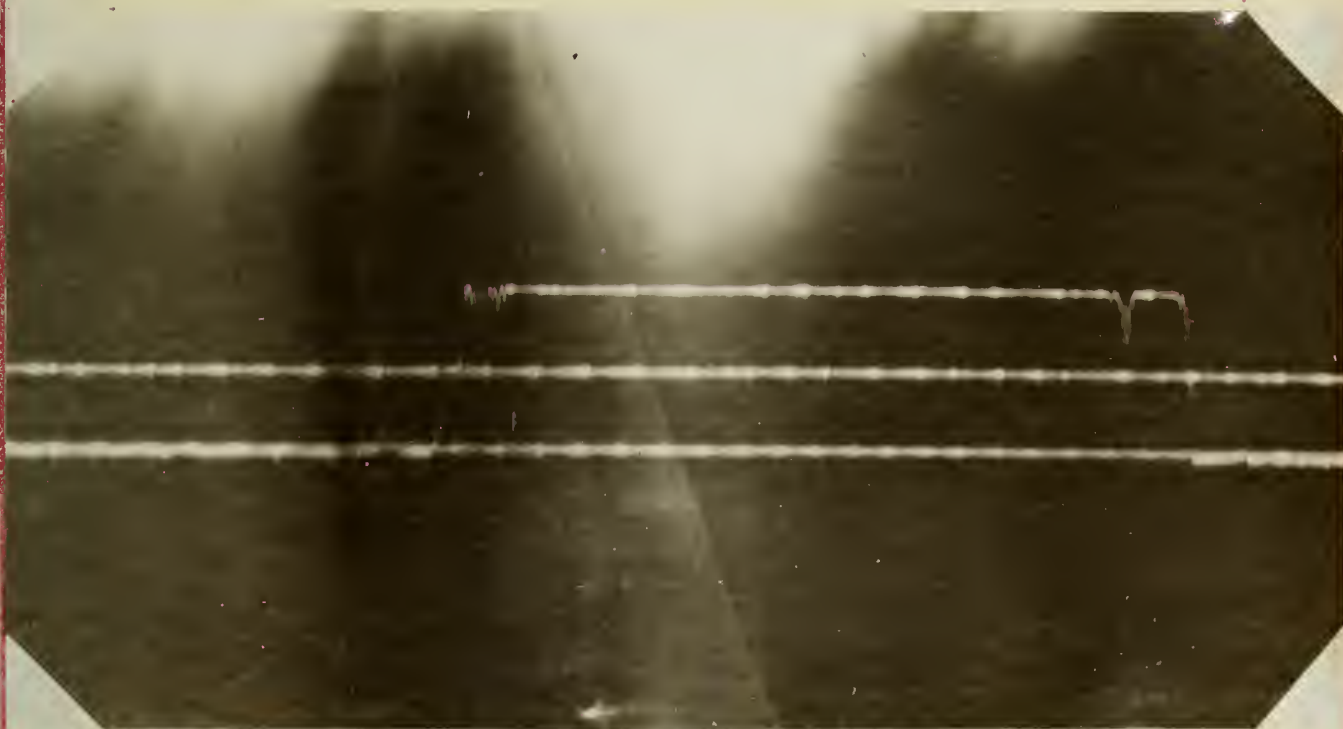
Fig. 49. Commutator Current, Calibrated. One Ampere through Commutator, One Ampere through Bridge Wire.
